## **Transport of ovine animals from Bulgaria to Turkey**

**Place of observation: Kapikule (border between Bulgaria and Turkey)**

**Date of observation: 08.10.2012**

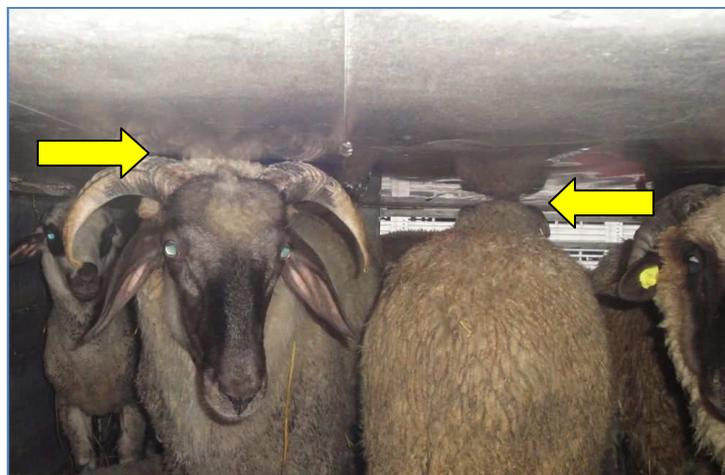
### Truck no. 1

- Insufficient ceiling height on first deck of goose neck, several animals are touching the ceiling with their heads
- Adequate ventilation hindered by insufficient ceiling height
- Several animals are coughing
- Straw bedding: very dirty
- Insufficient number of drinking devices in relation to the number of animals loaded (5 nipples on the left side in the main part of the truck plus 2 in the goose neck; no nipples on the right side)
- Truck not equipped with a ventilation system capable of maintaining a range of temperature from 5°C to 30°C (with a +/- 5°C tolerance)

*Animals touching the ceiling with their heads.*

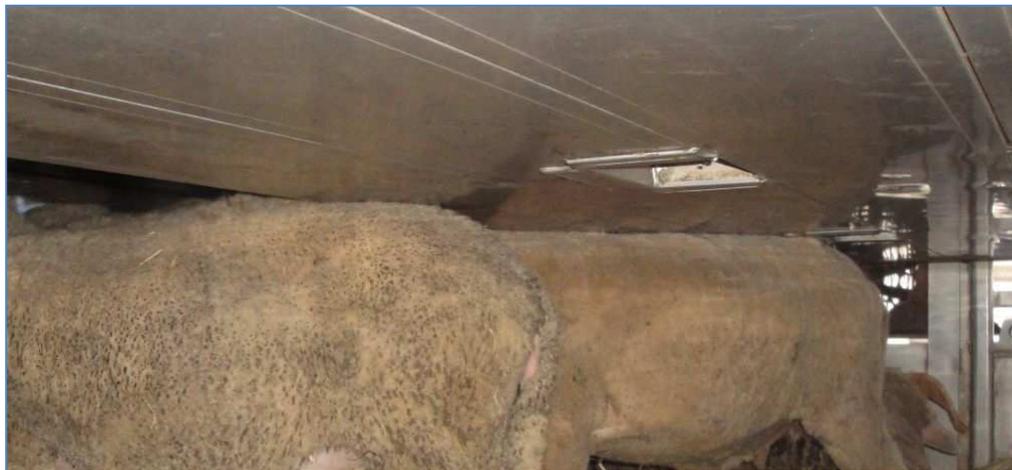
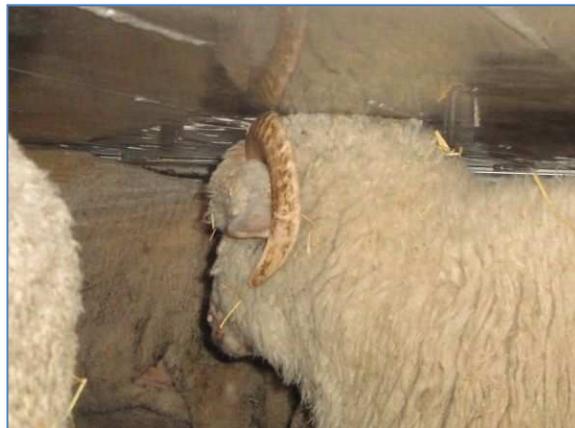
## **Truck no. 2**

- Clearly insufficient ceiling height, many animals touch the ceiling with their backs and heads
- Adequate ventilation hindered by insufficient ceiling height
- Several animals are coughing
- Truck not equipped with a ventilation system capable of maintaining a range of temperature from 5°C to 30°C (with a +/- 5°C tolerance)

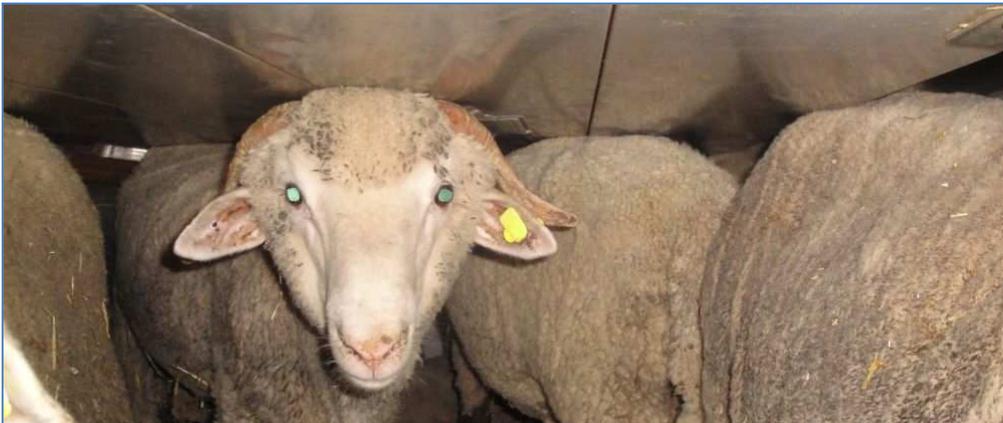
### **Truck no. 3**

- Clearly insufficient ceiling height, on first floor almost all animals touch the ceiling with head or back
- Adequate ventilation hindered by insufficient ceiling height
- Many animals are coughing and have nasal discharge
- Truck not equipped with a ventilation system capable of maintaining a range of temperature from 5°C to 30°C (with a +/- 5°C tolerance)

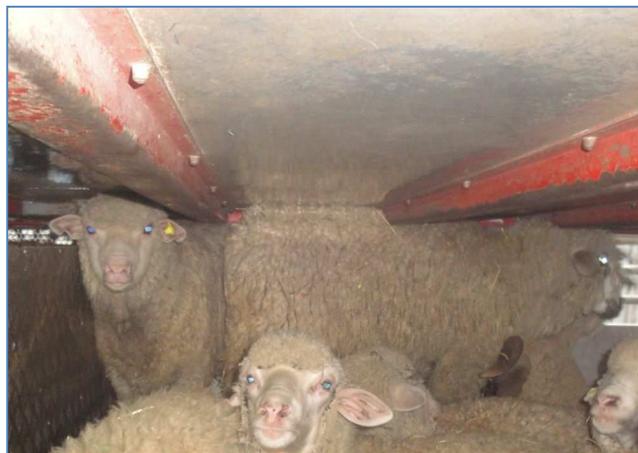
## **Truck no. 4**

- Clearly insufficient ceiling height; on first deck practically all animals touch the ceiling with head or back; as far as visible the situation on the 2<sup>nd</sup> and 3<sup>rd</sup> deck is the same; the ceiling of the 4<sup>th</sup> floor is lifted up
- Insufficient number of drinking devices in relation to the number of animals loaded (6 water nipples on the right side; none on the left side)
- Truck not equipped with a ventilation system capable of maintaining a range of temperature from 5°C to 30°C (with a +/- 5°C tolerance)
